SUBJ: EPA Asbestos Removal at 248 Jetton Street

## REMOVAL ACTION STATUS REPORT DAVIDSON ASBESTOS

**Property Address:** 248 Jetton Street, Davidson, Mecklenburg County, North Carolina

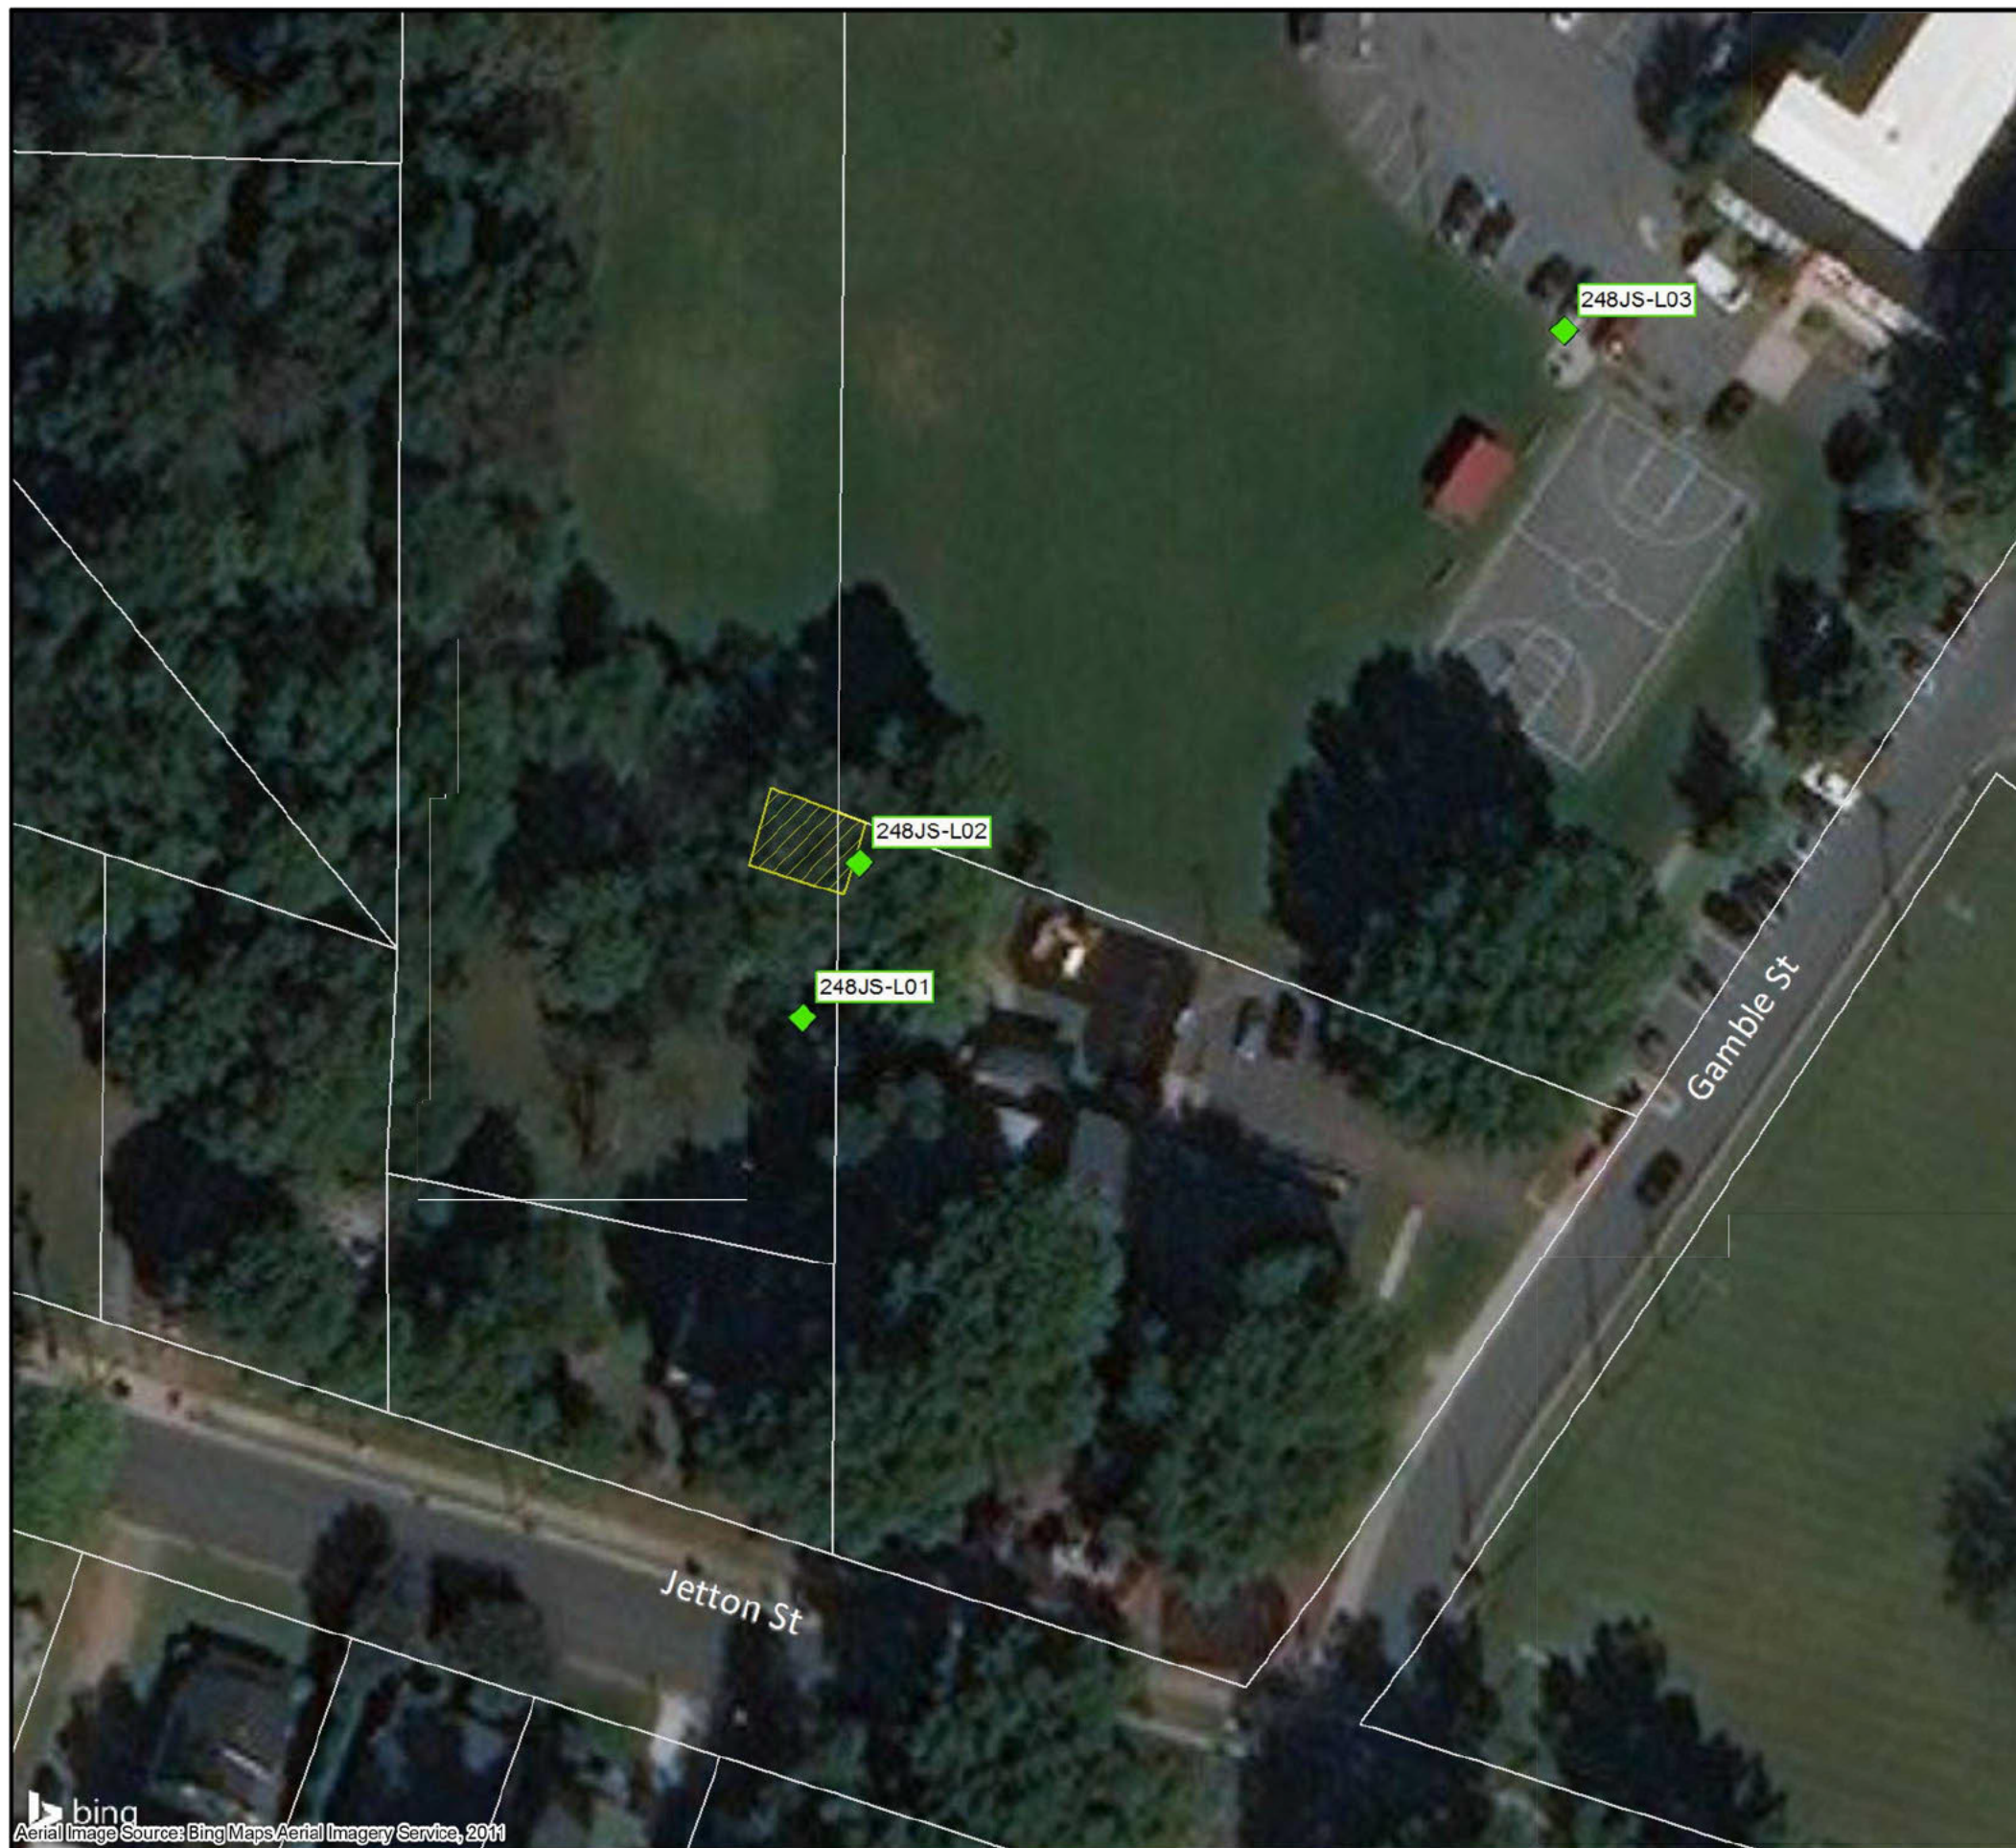
### FIGURE 1

Removal Areas and  
Air Sampling Locations

**Description of Removal Action:** The soil was excavated to an approximate maximum depth of 6 inches in the lawn (see Appendix 1). Visual inspections of the areas excavated for ACM were conducted by a State of North Carolina-accredited asbestos inspector and air monitor. Visible ACM was not detected at the time of the inspection and restoration of the excavated areas was allowed to commence.

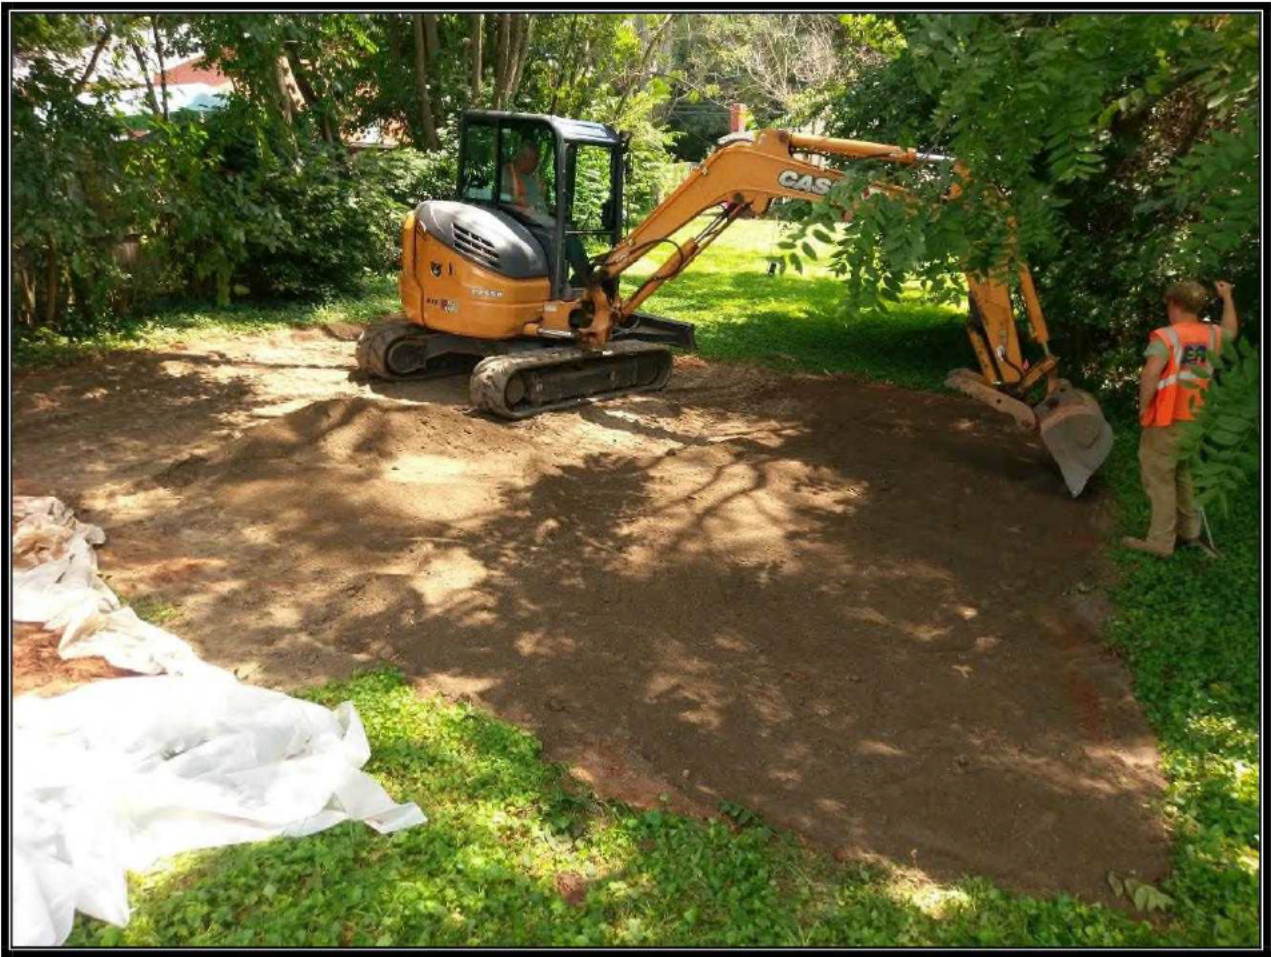
**OFFICIAL PHOTOGRAPH NO. 1**  
**U.S. ENVIRONMENTAL PROTECTION AGENCY**

**Subject:** The Emergency and Rapid Response Services (ERRS) contractor, Environmental Restoration, LLC (ER), used an excavator and hand tools to remove asbestos-containing materials (ACM) and asbestos-contaminated soil from the property located at 248 Jetton Street. ER used hoses to wet the asbestos-contaminated soil during removal activities.

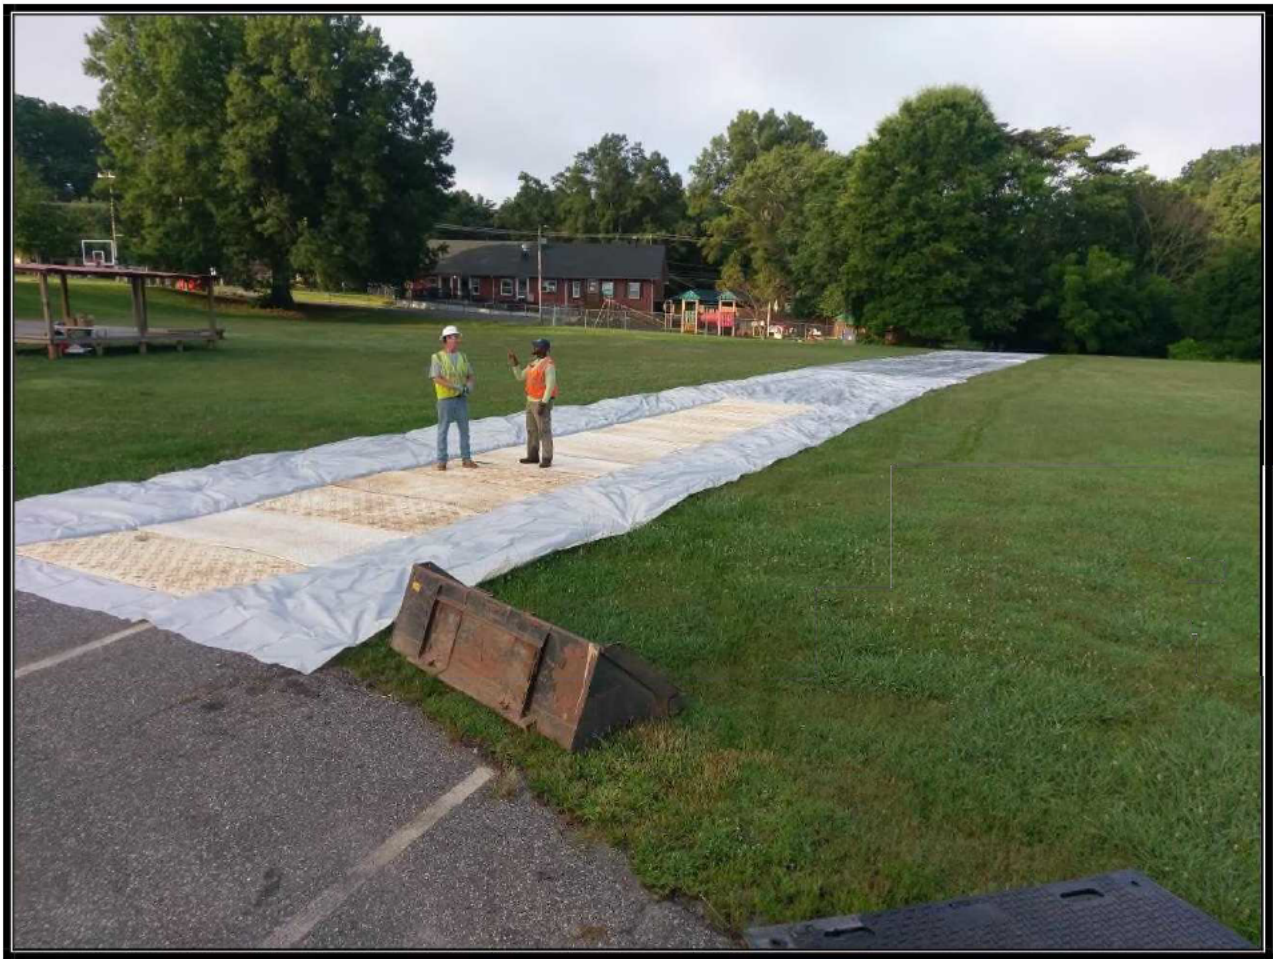
**OFFICIAL PHOTOGRAPH NO. 2**  
**U.S. ENVIRONMENTAL PROTECTION AGENCY**

**Subject:** ER used a skid steer and dump trucks to load and transport the asbestos-contaminated soil from the property to the staging area located at 206 Watson Street for disposal. ER placed plastic matting and sheeting under the path to the removal area and the dump trucks to prevent asbestos-contaminated soil from falling onto the ground and parking lot during removal activities.

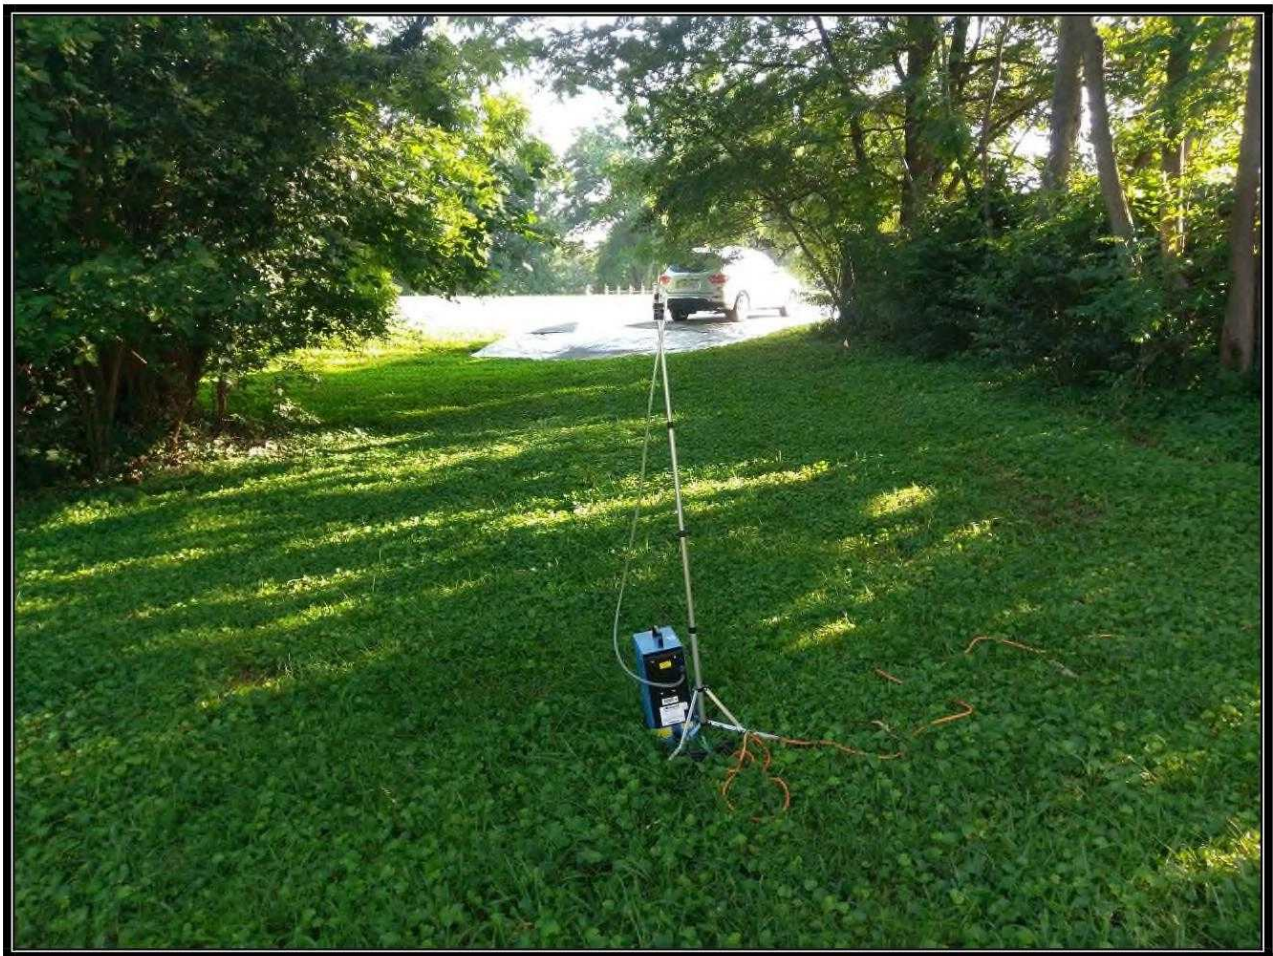
**OFFICIAL PHOTOGRAPH NO. 3**  
**U.S. ENVIRONMENTAL PROTECTION AGENCY**

**Subject:** Perimeter air sampling was conducted by a Tetra Tech Superfund Technical Assessment and Response Team (START), State of North Carolina-accredited air monitor, to evaluate the effectiveness of engineering and safety controls in preventing the off-site migration of asbestos fibers during removal activities.

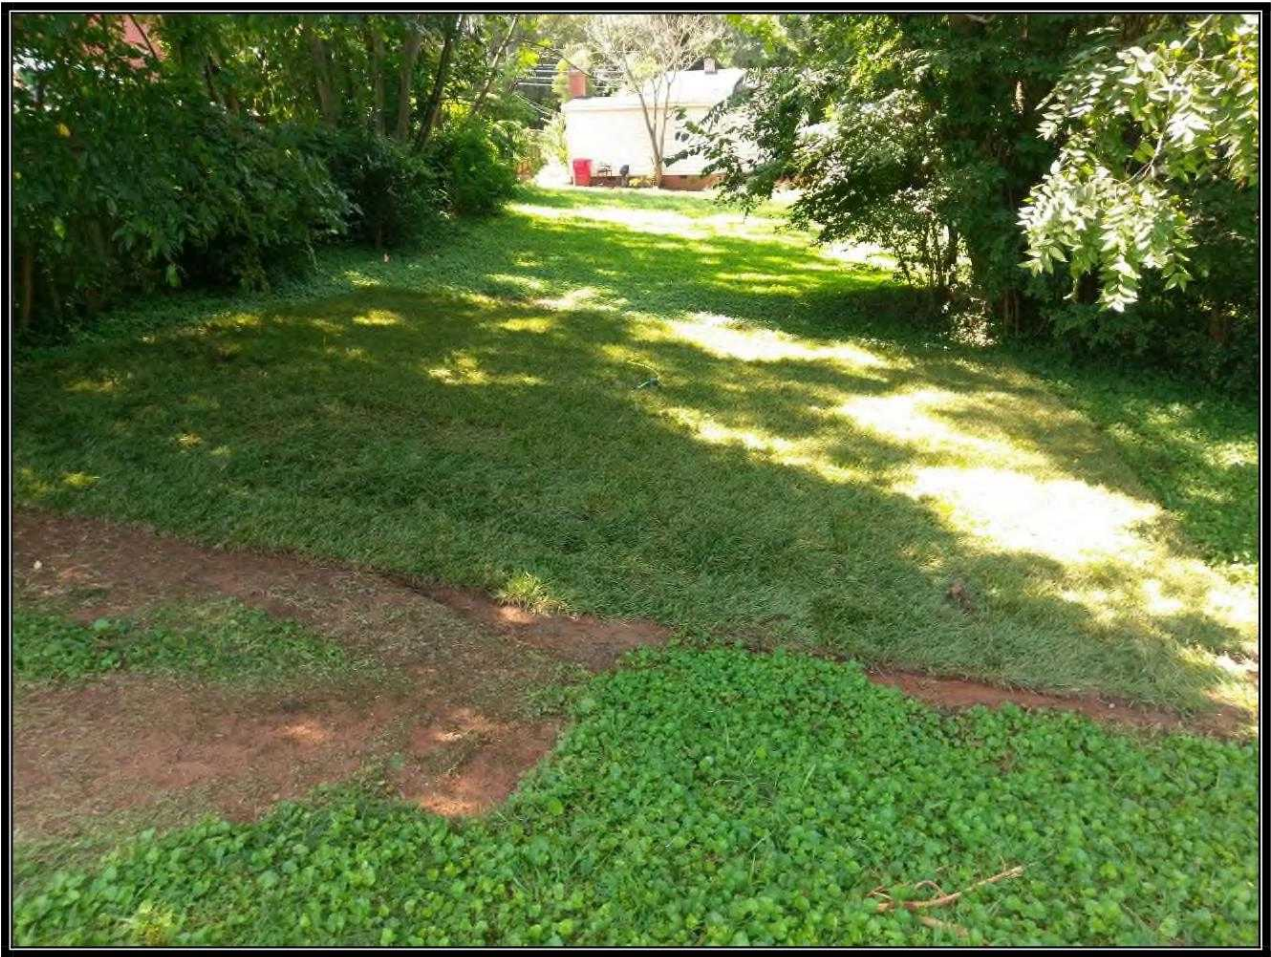
**OFFICIAL PHOTOGRAPH NO. 4**  
**U.S. ENVIRONMENTAL PROTECTION AGENCY**

<b>TDD Number:</b>	TT-01-071	<b>Location:</b>	Davidson Asbestos
<b>Orientation:</b>	Southwest	<b>Date:</b>	July 10, 2017
<b>Photographer:</b>	Paul Prys, Tetra Tech	<b>Witness:</b>	None
<b>Subject:</b>	ER installed sod in the excavated areas after the snow fencing and topsoil installation were completed. ER used hoses with sprinkler attachments to water the sod.
